# Pipe Dreams

The population of Colombo is increasing at a staggering pace. With new urbanisation underway, an innovative drainage and sewer project is taking place within the city, reports Harin Fernando.

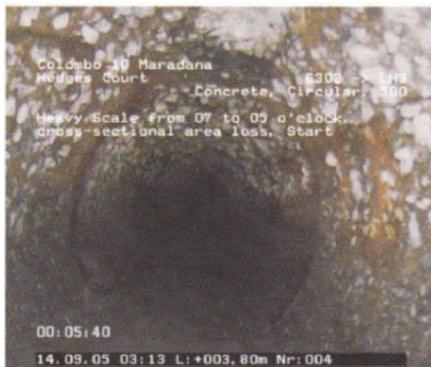
*The existing rusting mineral bound pipeline*

A survey of Colombo sewer pipes, carried out seven years ago, revealed an urgent need to have the pipes rehabilitated. The National Water Supply and Drainage Board gave the contract to rehabilitate the main sewer system in Colombo to Danish contracting group Per Aarsleff A/S. The Project Manager, Martin Rye Andersen, said “that the need to rehabilitate the system has existed for a long time. “The pipes are almost 100 years old. Any pipeline has to have rehabilitation. So it

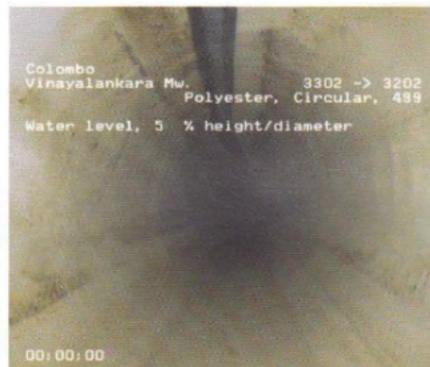
*After the liner is installed, with a smooth lasting finish*

The Aarsleff liner is made at a plant in Wattala of acid-proof polyester fibre impregnated with resin. The liner is produced in all lengths and wall thicknesses and can be sewn together, enabling pipe stretches of different dimensions to be rehabilitated in one run. Thus it is possible to rehabilitate several hundred metres at a time. Once the chemical impregnation has occurred, the pipe must be transported at low temperatures, to which end ice is being used as a coolant. Geographically, Colombo being wry flat, the lope of the piping is limited. When the rehabilitation is completed, the Colombo Municipal Council will be in charge of maintenance. Staff will be trained. According to the Project Manager, given the low slope, the risk of sedimentation is the biggest threat, but is fairly simple to get rid of. The new liner sections are expected to be good for use for another 50 years. This also means that current capacity can be increased by up to 10%, in keeping with anticipated population growth.

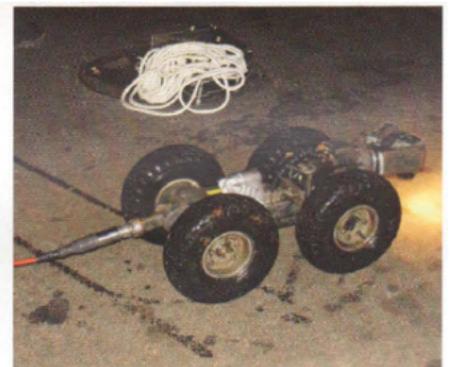
*Underground pipe survey module*
