# Pipe Dreams

The population of Colombo is increasing at a staggering pace. With new urbanisation underway, an innovative drainage and sewer project is taking place within the city, reports Harin Fernando.

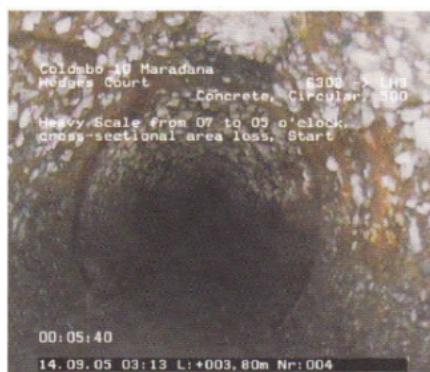
*The existing rusting mineral bound pipeline*

The Aarsleff liner is made at a plant in Wattala of acid-proof polyester fibre impregnated with resin. The liner is produced in all lengths and wall thicknesses and can be sewn together, enabling pipe stretches of different dimensions to be rehabilitated in one run. Thus it is possible to rehabilitate several hundred metres at a time. Once the chemical impregnation has occurred, the pipe must be transported at low temperatures, to which end ice is being used as a coolant. Geographically, Colombo being wry flat, the lope of the piping is limited. When the rehabilitation i completed, the Colombo Municipal Council will be in charge of maintenance. Staff will be trained. According to the Project Manager, given the low slope, the risk of sedimentation is the biggest threat, but is fairly simple to get rid of. The new liner sections are expected to be good for use for another 50 years. This also means that current capacity can be increased by up to 10%, in keeping with anticipated population growth.

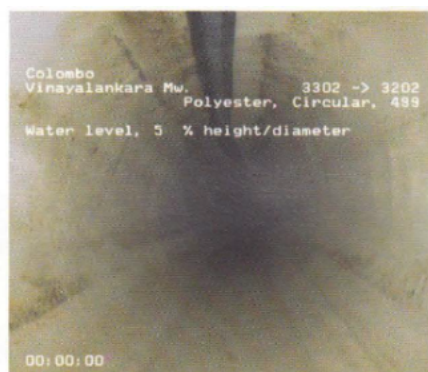
*After the liner is installed, with a smooth lasting finish*

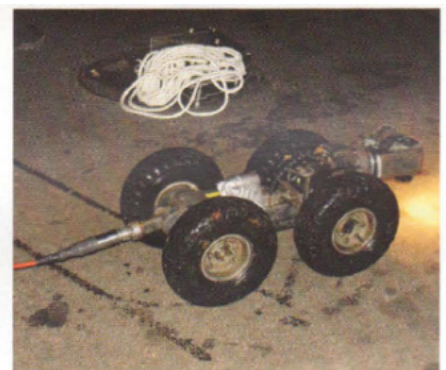
*Underground pipe survey module*
