Pipe Dreams

The population of Colombo is increasing at a staggering pace. With new urbanisation underway, an innovative drainage and sewer project is taking place within the city, reports Harin Fernando.

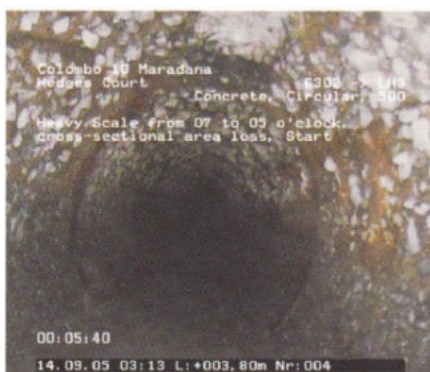
The existing rusting mineral bound pipeline

city wakes. When the installation is undertaken, existing sewer lines are diverted. The Colombo pipe system consists of circular and egg-shaped pipes dimensioned 450mm and 1830x1220mm respectively. The rehabilitation methods being applied include traditional Aarsleff Tube lining, as well as lining the pipes with prefabricated glass fibre elements.

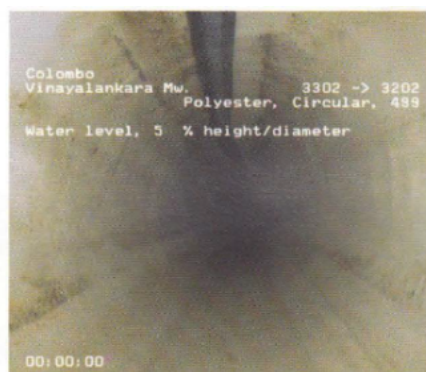
After the liner is installed, with a smooth lasting finish

The Aarsleff liner is made at a plant in Wattala of acid-proof polyester fibre impregnated with resin. The liner is produced in all lengths and wall thicknesses and can be sewn together, enabling pipe stretches of different dimensions to be rehabilitated in one run. Thus it is possible to rehabilitate several hundred metres at a time. Once the chemical impregnation has occurred, the pipe must be transported at low temperatures, to which end ice is being used as a coolant. Geographically, Colombo being wry flat, the lope of the piping is limited. When the rehabilitation is completed, the Colombo Municipal Council will be in charge of maintenance. Staff will be trained. According to the Project Manager, given the low slope, the risk of sedimentation is the biggest threat, but is fairly simple to get rid of. The new liner sections are expected to be good for use for another 50 years. This also means that current capacity can be increased by up to 10%, in keeping with anticipated population growth.
