Pipe Dreams

The population of Colombo is increasing at a staggering pace. With new urbanisation underway, an innovative drainage and sewer project is taking place within the city, reports Harin Fernando.

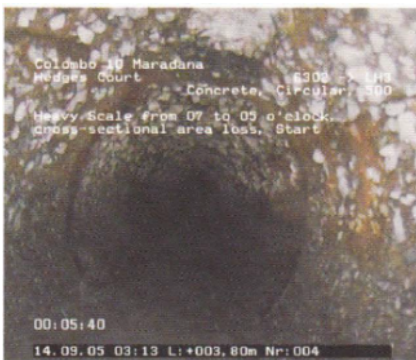
The existing rusting mineral bound pipeline

part of the project. Attention to the sewer pipes were needed not just because of a lack of maintenance, but also because the sewer network capacity is stretched to its capacity. Colombo's low altitude, although above sea level, results in the retention of ground water in the soil. This means that when a pipe becomes defective the ground water seeps in. This is followed by the surrounding soil and eventually leads to pipe and system collapses, as seen recently in Maradana. The contract to rehabilitate the over-stressed system is financed by the Danish International Development Agency (DANIDA), and is the first under their mixed credit programme to Sri Lanka. The project is to be implemented over a period of 32 months; having commenced in March 2005, work is on target to be completed by November 2007. Working in Sri Lanka has not been without its fair share of problems, according to the Project Manager.

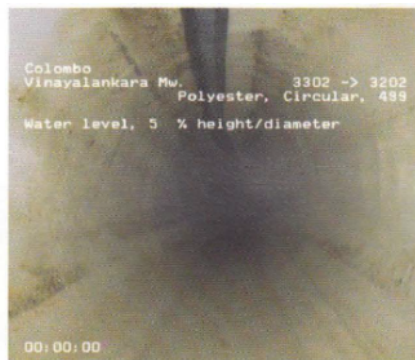
After the liner is installed, with a smooth lasting finish

The Aarsleff liner is made at a plant in Wattala of acid-proof polyester fibre

impregnated with resin. The liner is produced in all lengths and wall thicknesses and can be sewn together, enabling pipe stretches of different dimensions to be rehabilitated in one run. Thus it is possible to rehabilitate several hundred metres at a time. Once the chemical impregnation has occurred, the pipe must be transported at low temperatures, to which end ice is being used as a coolant. Geographically, Colombo being wry flat, the lope of the piping is limited. When the rehabilitation is completed, the Colombo Municipal Council will be in charge of maintenance. Staff will be trained. According to the Project Manager, given the low slope, the risk of sedimentation is the biggest threat, but is fairly simple to get rid of. The new liner sections are expected to be good for use for another 50 years. This also means that current capacity can be increased by up to 10%, in keeping with anticipated population growth.

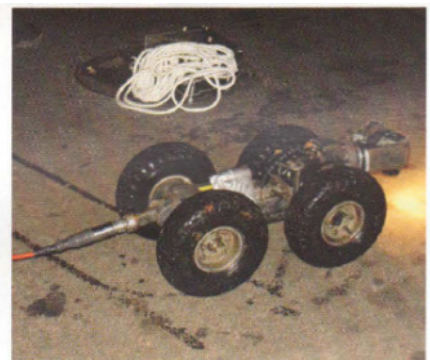
Underground pipe survey module
