# Pipe Dreams

The population of Colombo is increasing at a staggering pace. With new urbanisation underway, an innovative drainage and sewer project is taking place within the city, reports Harin Fernando.

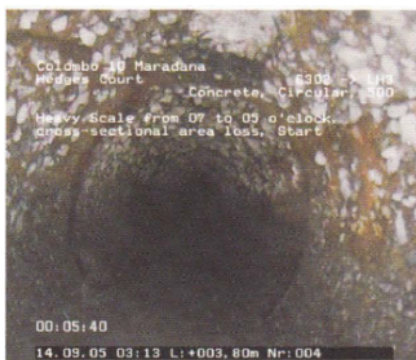
*The existing rusting mineral bound pipeline*

A survey of Colombo sewer pipes, carried out seven years ago, revealed an urgent need to have the pipes rehabilitated. The National Water Supply and Drainage Board gave the contract to rehabilitate the main sewer system in Colombo to Danish contracting group Per Aarsleff A/S. The Project Manager, Martin Rye Andersen, said “that the need to rehabilitate the system has existed for a long time. “The pipes are almost 100 years old. Any pipeline has to have rehabilitation. So it was decided to take the most critical pipelines, those leading to the main pumping station in Colombo, and apply remedial action.”

part of the project. Attention to the sewer pipes were needed not just because of a lack of maintenance, but also because the sewer network capacity is stretched to its capacity. Colombo's low altitude, although above sea level, results in the retention of ground water in the soil. This means that when a pipe becomes defective the ground water seeps in. This is followed by the surrounding soil and eventually leads to pipe and system collapses, as seen recently in Maradana. The contract to rehabilitate the over-stressed system is financed by the Danish International Development Agency (DANIDA), and is the first under their mixed credit programme to Sri Lanka. The project is to be implemented over a period of 32 months; having commenced in March 2005, work is on target to be completed by November 2007. Working in Sri Lanka has not been without its fair share of problems, according to the Project Manager.

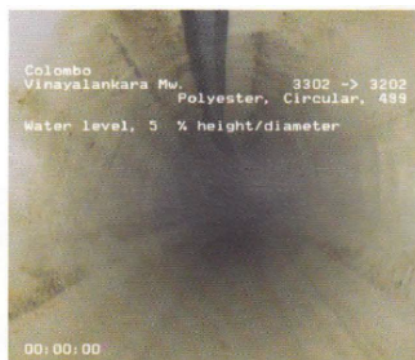
*After the liner is installed, with a smooth lasting finish*

The Aarsleff liner is made at a plant in Wattala of acid-proof polyester fibre

impregnated with resin. The liner is produced in all lengths and wall thicknesses and can be sewn together, enabling pipe stretches of different dimensions to be rehabilitated in one run. Thus it is possible to rehabilitate several hundred metres at a time. Once the chemical impregnation has occurred, the pipe must be transported at low temperatures, to which end ice is being used as a coolant. Geographically, Colombo being wry flat, the lope of the piping is limited. When the rehabilitation i completed, the Colombo Municipal Council will be in charge of maintenance. Staff will be trained. According to the Project Manager, given the low slope, the risk of sedimentation is the biggest threat, but is fairly simple to get rid of. The new liner sections are expected to be good for use for another 50 years. This also means that current capacity can be increased by up to 10%, in keeping with anticipated population growth.
